OSWEGO RIVER BASIN

LOWER FULTON DAM (GRANBY)

OSWEGO COUNTY **NEW YORK**

PHASE I INSPECTION REPORT NATIONAL DAM SAFETY PROGRAM

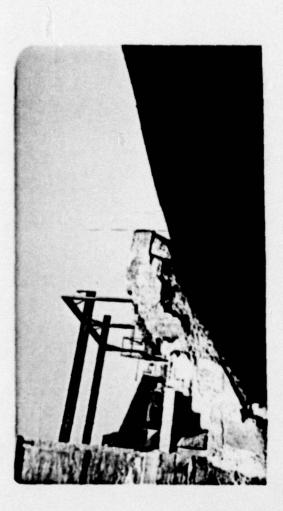
Spillway abutment wall on east side of river. Concrete
is severely eroded.

A concrete wall serves as the westerly abutment of the dam and the separation wall for the forebay of the power station situated on the west side of the river. The dam side of this abutment wall is deteriorated and eroded from the effects of spillway flow. The downstream wall of the forebay has deteriorated areas and leakage occurring. No indication of structural instability was noted, however, concrete in the dam's east abutment wall is severely eroded.

- Repair the abutment walls which are severely eroded at the waterline.
- 4. Repair the mechanical equipment which operates the sluice gates.
- 5. Investigate and repair the structural integrity of the lock walls, particularly where the walls are attached or adjacent to the spillway or where a hazard potential related to loss of life or property is presented.

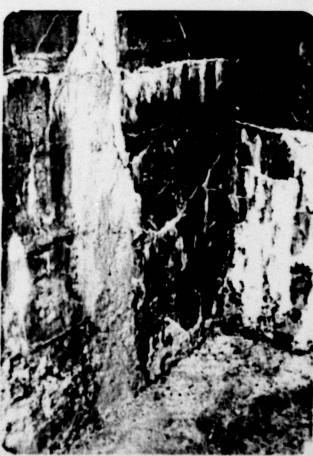
11. Deterioration of downstream walls of lock.

Repair of deteriorated concrete in the navigation lock structure also should be undertaken.
